CALIFORNIA BLACK OAK DRYING PROBLEMS AND THE BACTERIAL FACTOR.(U)

Research
Paper
FPL 344
1979

California Black Oak Drying Problems and The Bacterial Factor.

10 James C. Ward
Del/Shedd

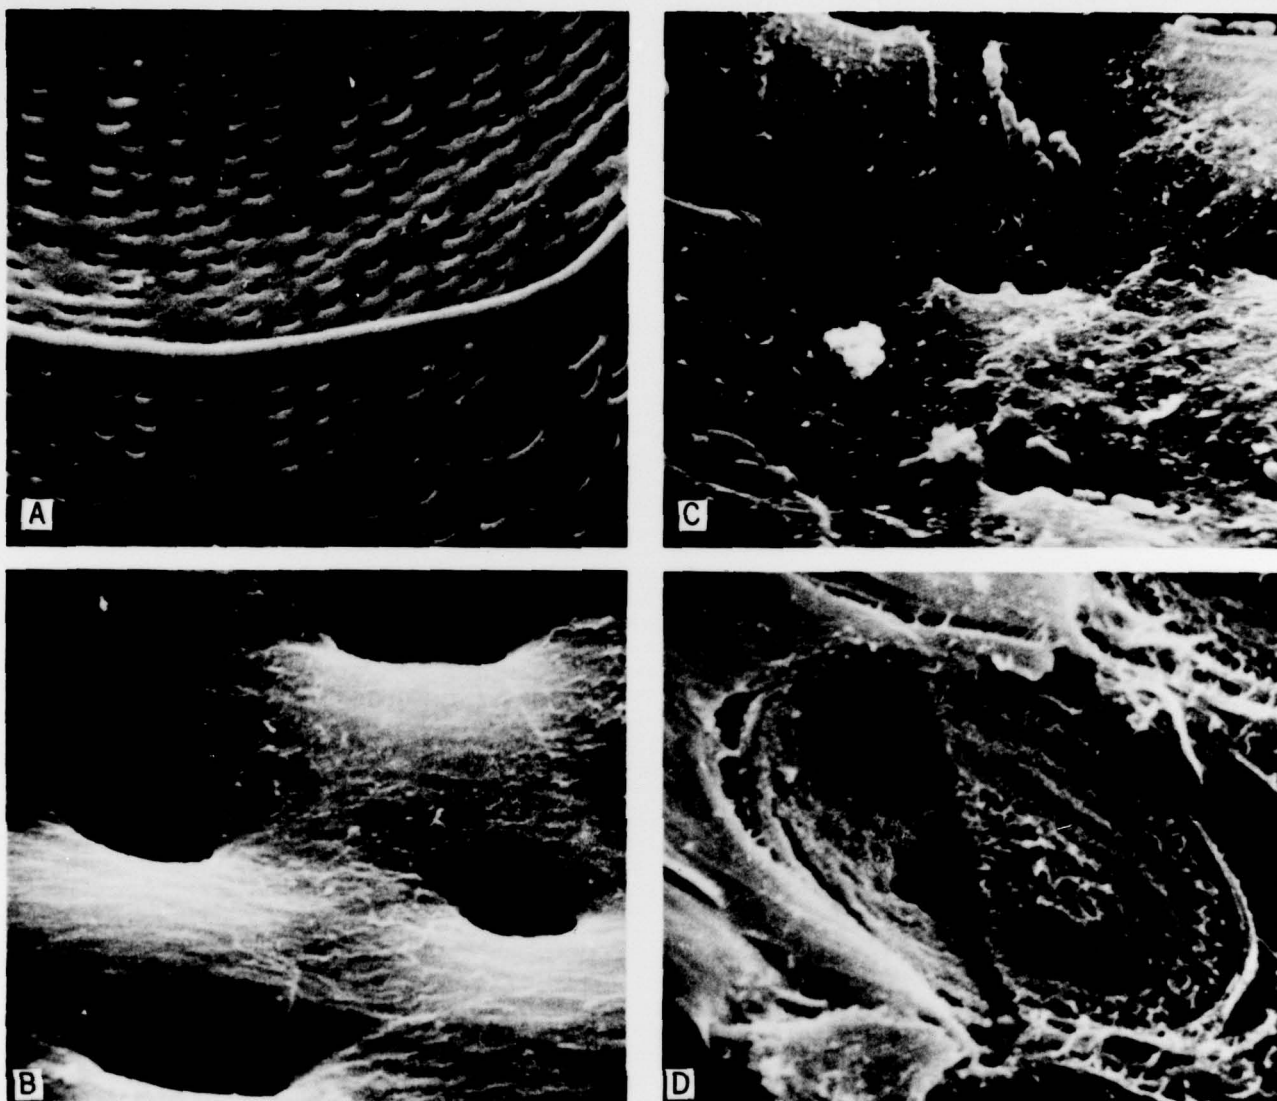
Figure 1.—Scanning electron micrographs of noninfected sapwood (A-B) and bacterially infected heartwood (C-D) from living California black oak trees. Spore of *Clostridium* sp. within the bordered pit in D.
(M 147 430, M 147 428, M 147 429, M 147 428)

California black oak trees can be infected by anaerobic bacteria in a manner similar to that reported for eastern red and black oaks (Ward 1972, Ward *et al.* 1972). Results from both the large-scale mill study and the FPL laboratory study indicate that the bacterially infected heartwood can be related to the unexpected occurrence of drying degrade from honeycomb, ring failure, and collapse.

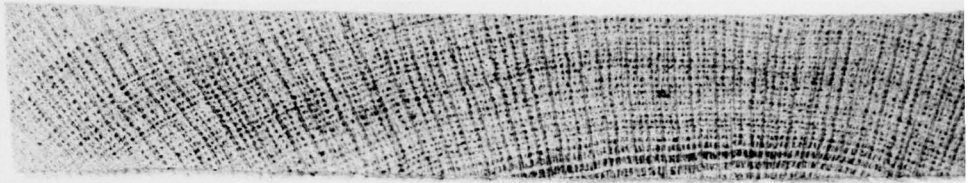
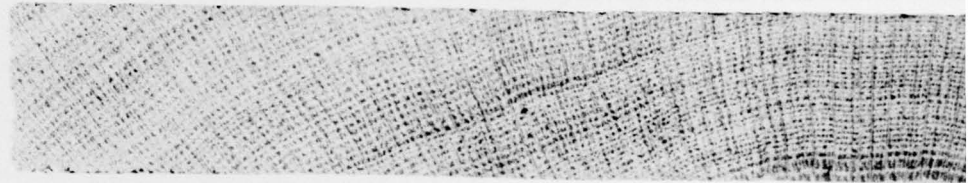
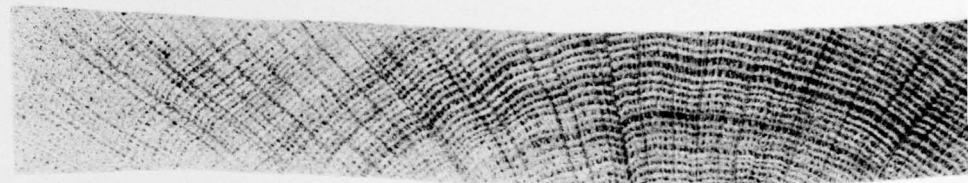
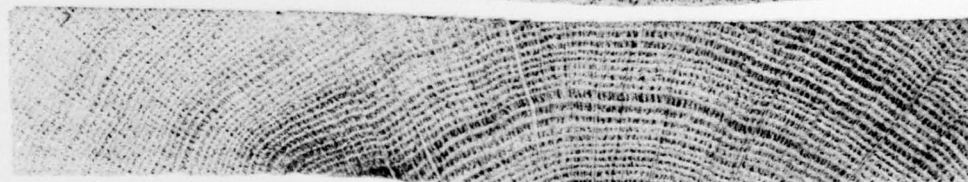
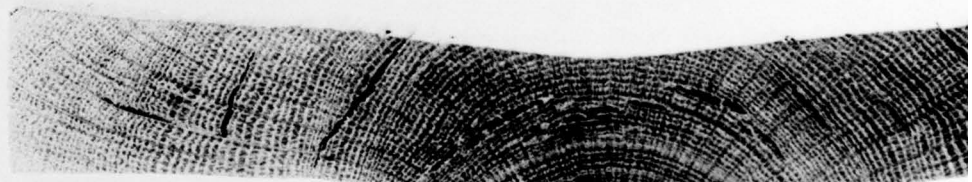
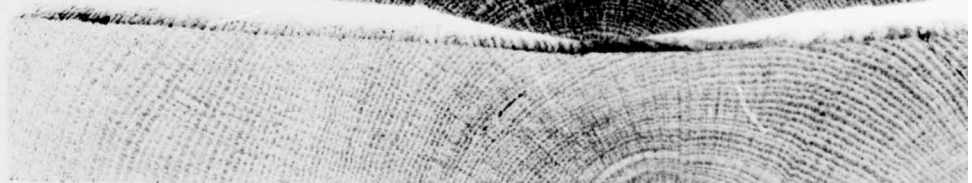
Ring failure was present in cross sections cut from both the kiln- and air-dried samples of the rancid board, but ring failure was more severe under kiln-drying conditions (fig. 4). Ring failure did not develop in normal, noninfected heartwood or in the infected heartwood of the mixed sample. Honeycomb developed in the kiln-dried rancid sample, but could not be detected in the air-dried sample. The mixed heartwood sample developed a few internal hairline checks in the bacterial heartwood under kiln drying but not air drying. Neither the surface checks which closed during the final drying stages nor the hairline internal checks are visible in

Collapse or excessive shrinkage in thickness is evident in all samples containing bacterial heartwood when compared with cross sections from normal, noninfected heartwood samples.

Figure 4.—Cross sections from matched sample boards of 4/4 California black oak—dried under laboratory conditions to 6 percent moisture content. KD = kiln dried, AD = air dried.
(M 147 113)

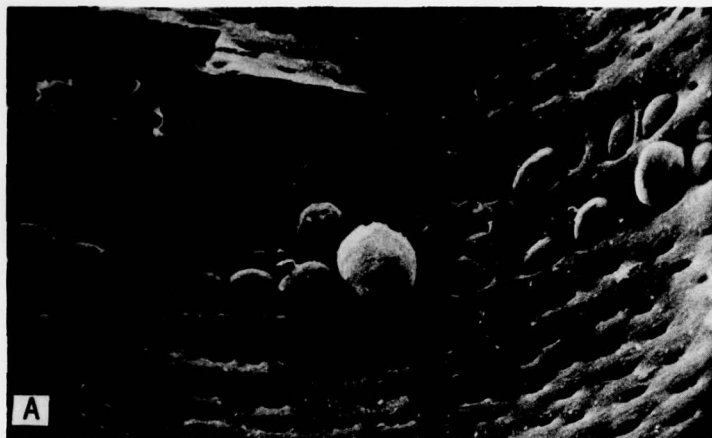
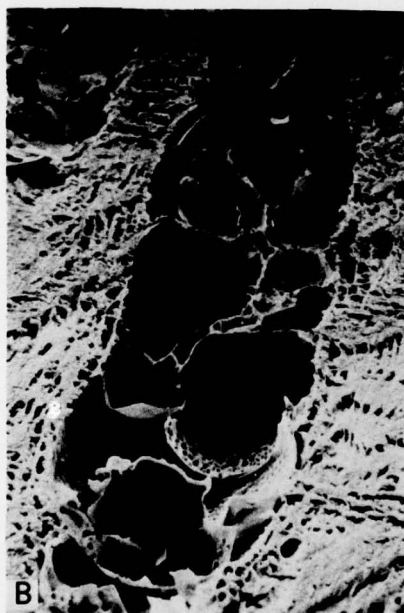
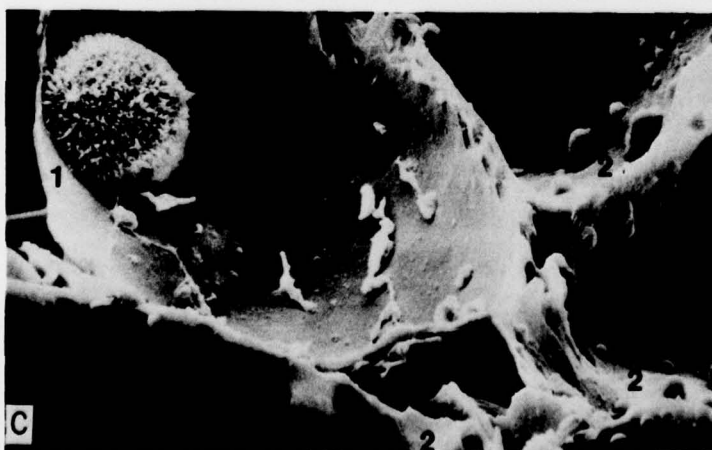
The presence of tyloses is generally considered a diagnostic characteristic of white oaks rather than the red and black oaks. But California black oak is an exception. All heartwood, both normal and infected, that was examined in this study contained an abundance of tyloses. Furthermore, a comprehensive study of the anatomy of American oaks by Williams (1942) found that tyloses are the rule rather than the exception in California black oak.

Figure 5.—Scanning electron micrographs of tyloses in living California black oak. A. Vessel from sapwood to heartwood transition zone showing initial tyloses development from ray pits. B. Vessel from noninfected heartwood showing abundant tyloses growth. C. Closeup of tyloses in B showing: (1) Crystal inclusion inside one tyloses and (2) Secondary burgeoning from membranes within adjacent tyloses.

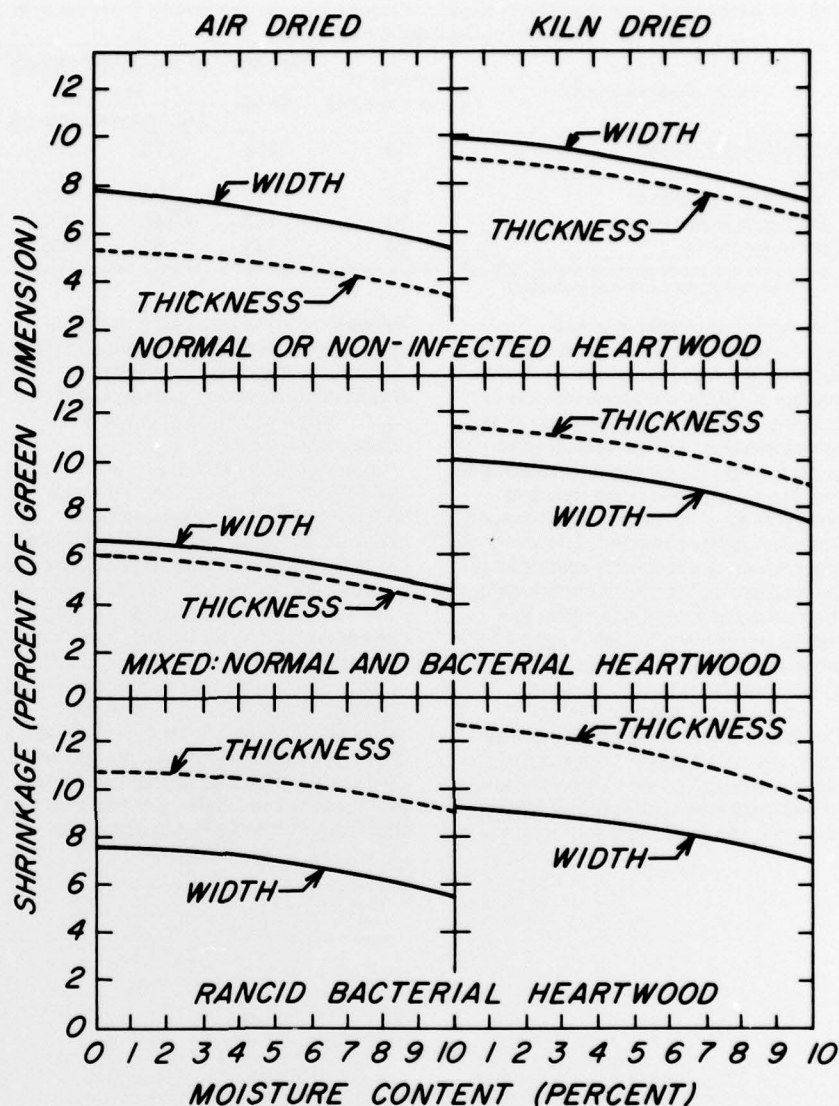
The greater shrinkage of bacterially infected California black oak is largely associated with collapse, especially across the thickness of the board. Collapse seems to be more prominent in California black oak than in most of the eastern red and black oaks. The deep collapse zones in California black oak can be attributed to relatively severe drying conditions, bacterially weakened wood, and plugging of the vessels or pores with tyloses. Moisture movement through the vessels is retarded by the tyloses and bacterial debris. Tensile stresses that are set up are sufficient to cause collapse of the weakened wood tissue.

The influences of bacterial weakening of the wood and of drying conditions on the dimensional shrinkage of California black oak are illustrated in figure 6.

Figure 6.—Effect of drying conditions and bacterial tree infections on the dimensional shrinkage of flatsawn 4/4 California black oak boards. All heartwood contained tyloses.
(M 146 706)
